**Examination of Poly Implant Prothèse  
(PIP) silicone breast implant retrieval  
study by Swarts *et al* (2012)**

**Quality First International  
February 2013**

## Examination of Poly Implant Prothèse (PIP) silicone breast implant retrieval study by Swarts *et al* (2012)

*Haroon Atchia, Chief Executive Officer & Technical Director, Quality First International*

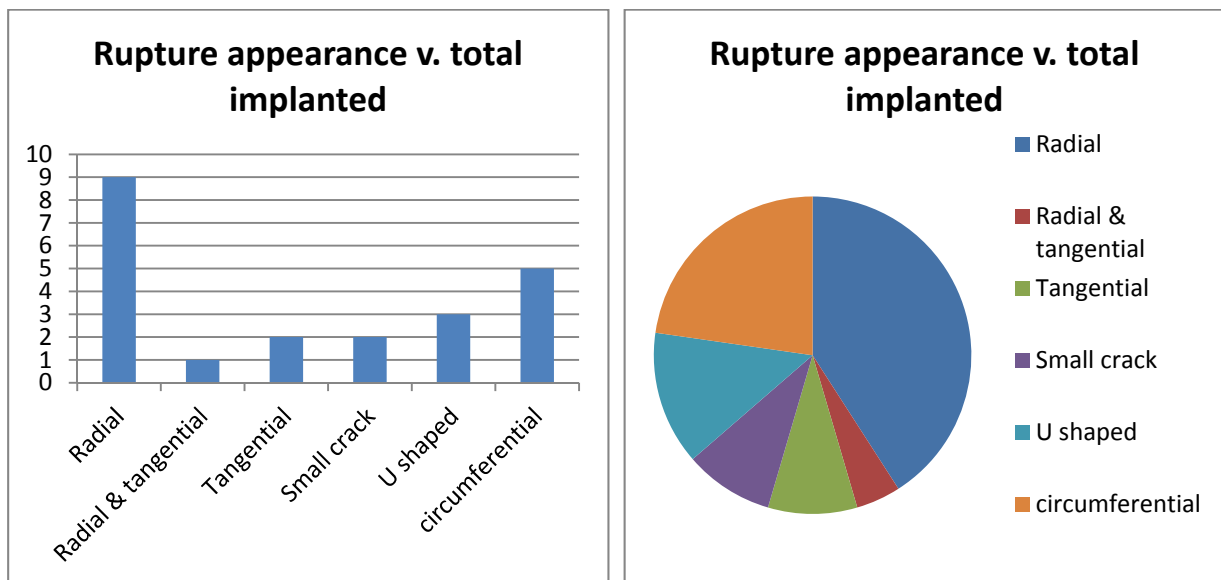
**Figure 1** Appearance of rupture in retrieved PIP implants (after Swarts *et al*, 2012)

Assuming that rupture appearance denominators are truly distinct, easy distinguishable and consistent, observations by Swarts *et al* were analysed and plotted histographically and pie-charts produced. Results indicate that radial rupture dominates in the entire implanted population, however, dominance mainly originates from incidence of radial rupture in units implanted in the right breast (Figures 1 and 2). It is impossible to determine whether the differences observed are statistically relevant and conjecture what the causes might be.

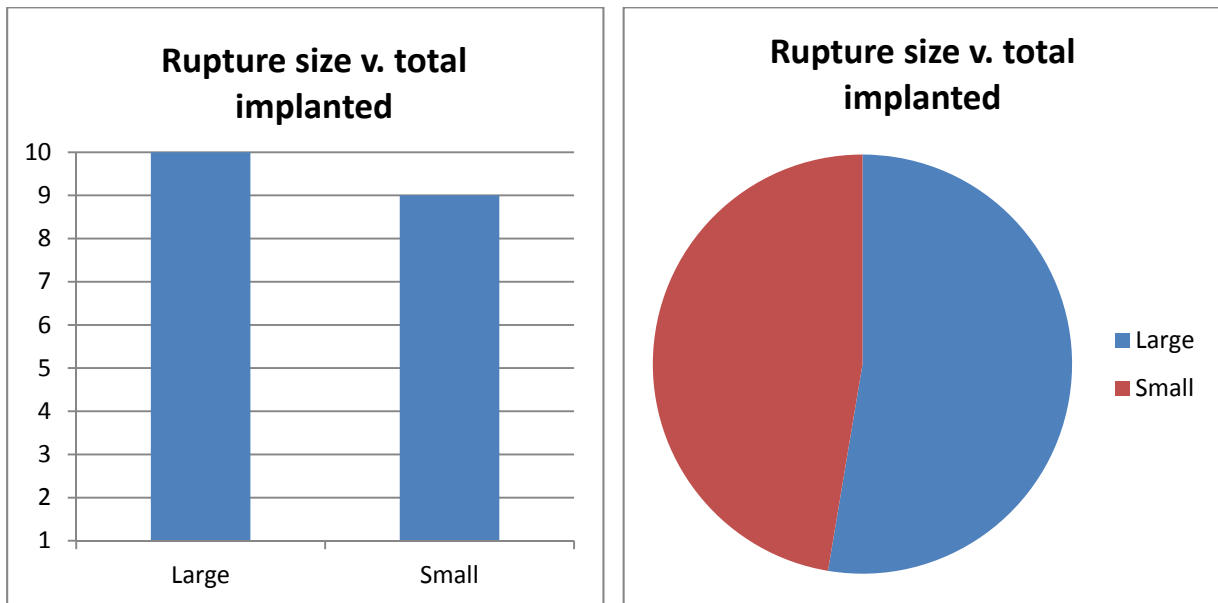
Relative rupture size (left and right), categorised as small or large does not appear revealing (Figure 4). Considerably further and more critical examinations would be

**Figure 4** Relative size of rupture observed in retrieved PIP implants (after Swarts *et al*, 2012)

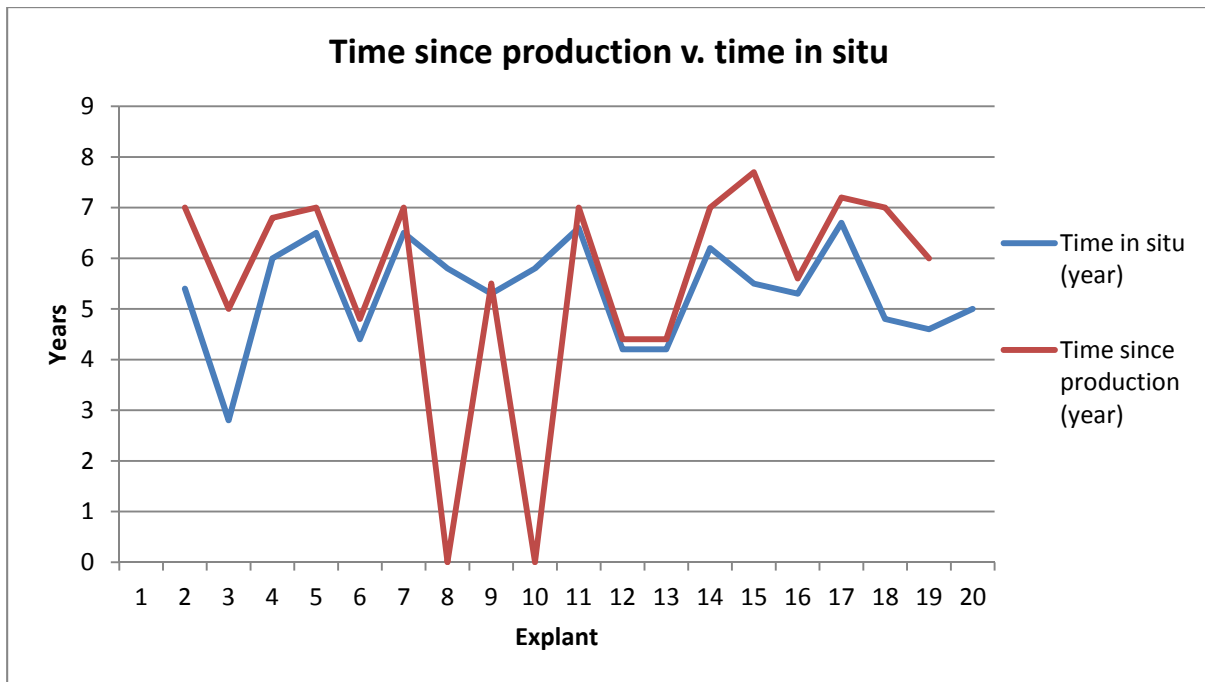
Information in Table 3 was plotted in order to reveal existence of time dependence (Figure 5 Time since production v. time in situ). Total time *in situ* was 101.6 (32.8 left breast implants and 68.8 right breast implants) (mean 5.35) years. There is little evidence suggesting significant difference in longevity between left and right breast implants. Unfortunately, time since production was unknown for implants 8, 10 and 19. Index of average time since production *versus* time *in situ* suggests horizontal linearity, however efforts to establish time dependence on data available in the research by Swarts *et al* (2012) proved difficult for several reasons. Since certain information on implants number 7 and 9 was incomplete, they were excluded from calculation of linear average attempting to investigate any relation between durability of implants in the series. Figure 6 indicates a central tendency about respective medians around 6 years since production and 5 years *in situ* time (but interpretation is far from conclusive).

**Figure 5** Examination of time to failure from data from Swarts *et al* (2012) on retrieved
